Fresh Water / Winterization Tank Add-On Kit Instruction Sheet

Kit Number: 526-10-100600

Kit Description: 3 Gallon Rinse Water / Winterization Tank Kit

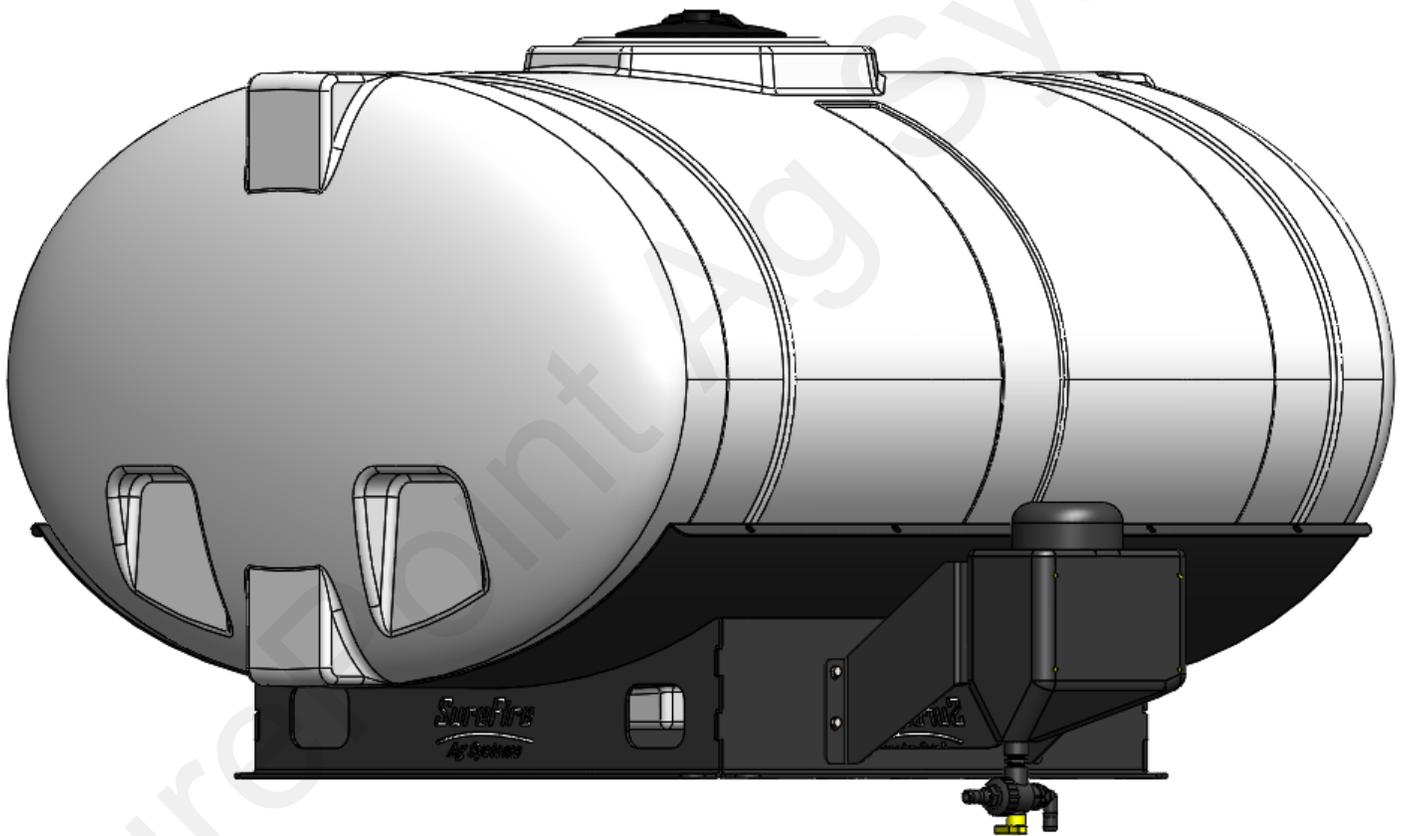
Parts List and Exploded View

ITEM NO.	PART NUMBER	DESCRIPTION	QTY.
1	100-075NIP-SH	3/4" Short Nipple	1
2	101-075075-H	3/4" MPT x 3/4" HB	1
3	101-075075-90	3/4" MPT x 3/4" HB - 90 Degree	1
4	102-075SUBV-3BL	3/4" Union Valve 3 Way	1
5	300-050012-5	5/16" x 3/4" Hex Head Bolt - G5	4
6	330-05	5/16" Flat Washer	4
7	331-05	5/16" Lock Washer	4
8	350-0605	SS Hose Clamp - Size 6 - 7/8" Diameter (fits 3/8" and 1/2" AG200)	2
9	384-1095	Hardware Kit - 3/8" Hex Cap Bolts and 3/8" Flange Nuts	1
10	396-4163Y1	Fresh Water / Winterization Tank Add-On Kit Instructions	1
11	400-2029A1-BK	3 Gallon Water Tank Bracket for 400 & 500 Gallon Cradles	1
12	727-05-SP0003-RT-BLACK	Black 3 Gallon Specialty Tank	1

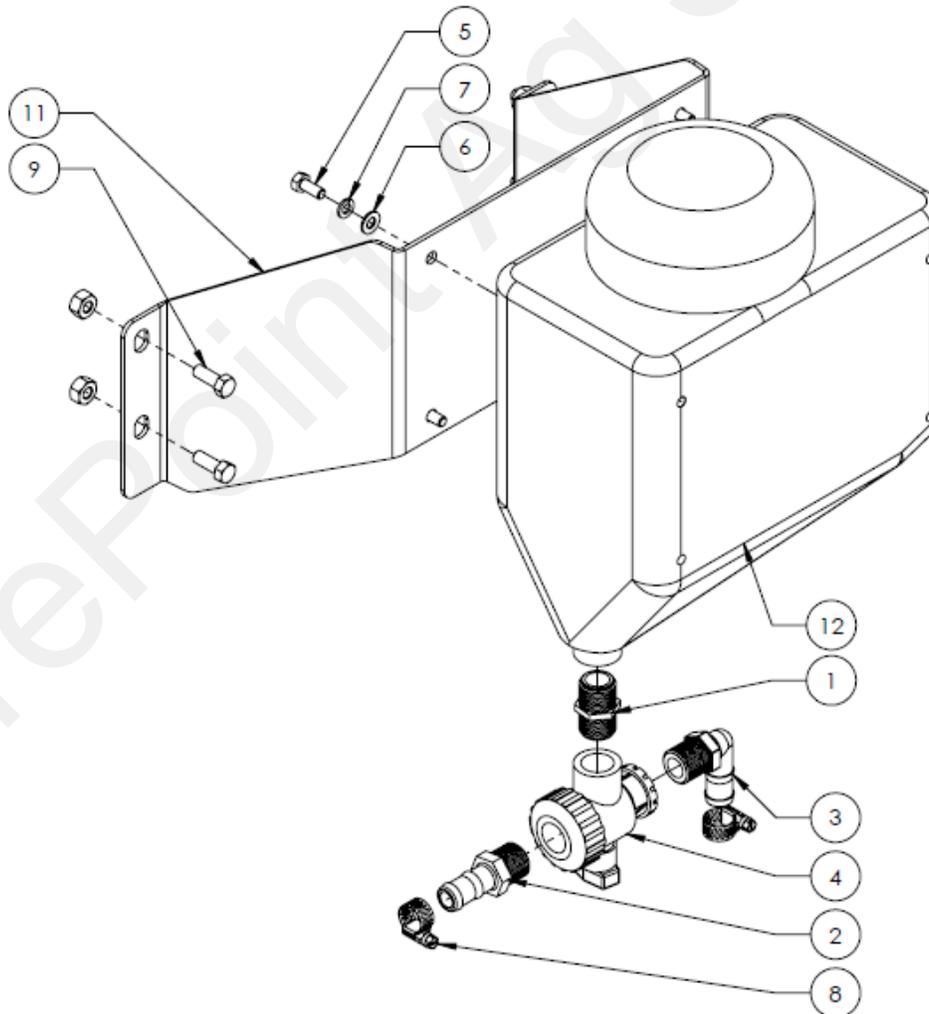
Step by Step Instructions

1. Use 5/16" bolt, lock washer, and flat washer to mount the tank to the mounting bracket as shown.
2. Assemble tank valve plumbing as shown using pipe thread sealant.
3. Mount the fresh water / winterization tank assembly to the side of the SureFire tank cradle as shown using (4) 3/8" bolts and flange nuts.

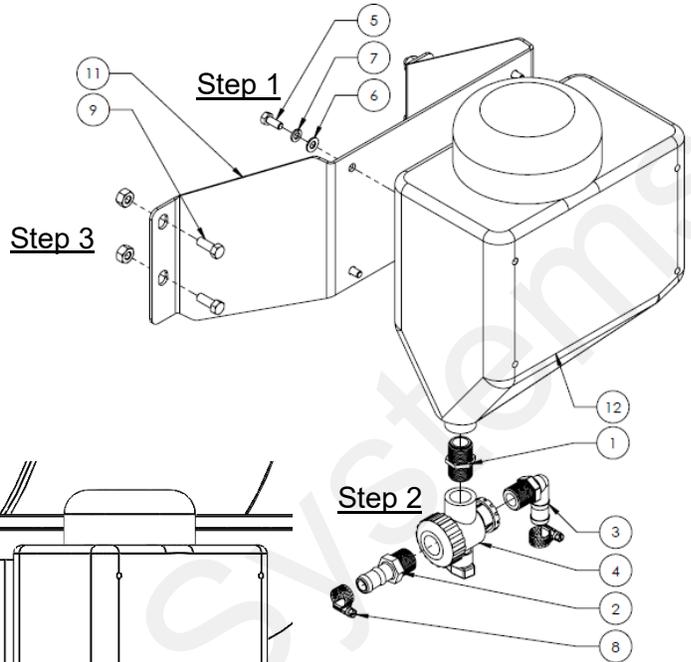
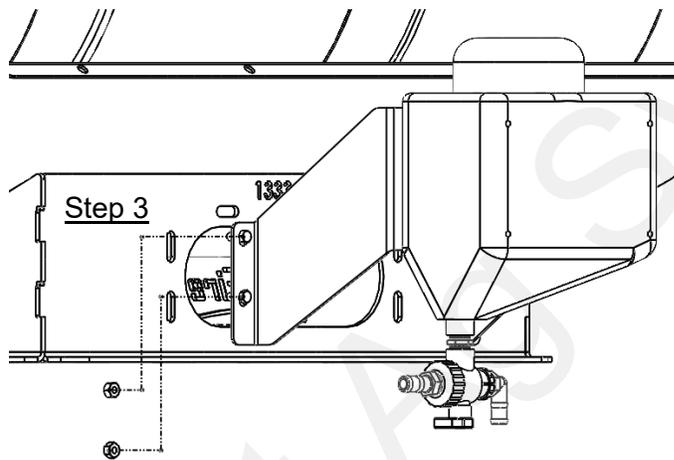
Operational Instructions

Tank Kit can be used to fill full of clean rinse water or RV anti-freeze as recommended by SurePoint Ag Systems for winterizing your system. In some cases, 3 gallons may not be sufficient to completely fill the system. Route a hose from the provided hose barb to the inlet side of the pump for easy flushing of the system. The 3-Way valve in the middle position is off.
